# Final Report

Wisconsin Highway Research Program

Project 0092-02-05

Performance of Shoulders Adjacent to Concrete Pavements

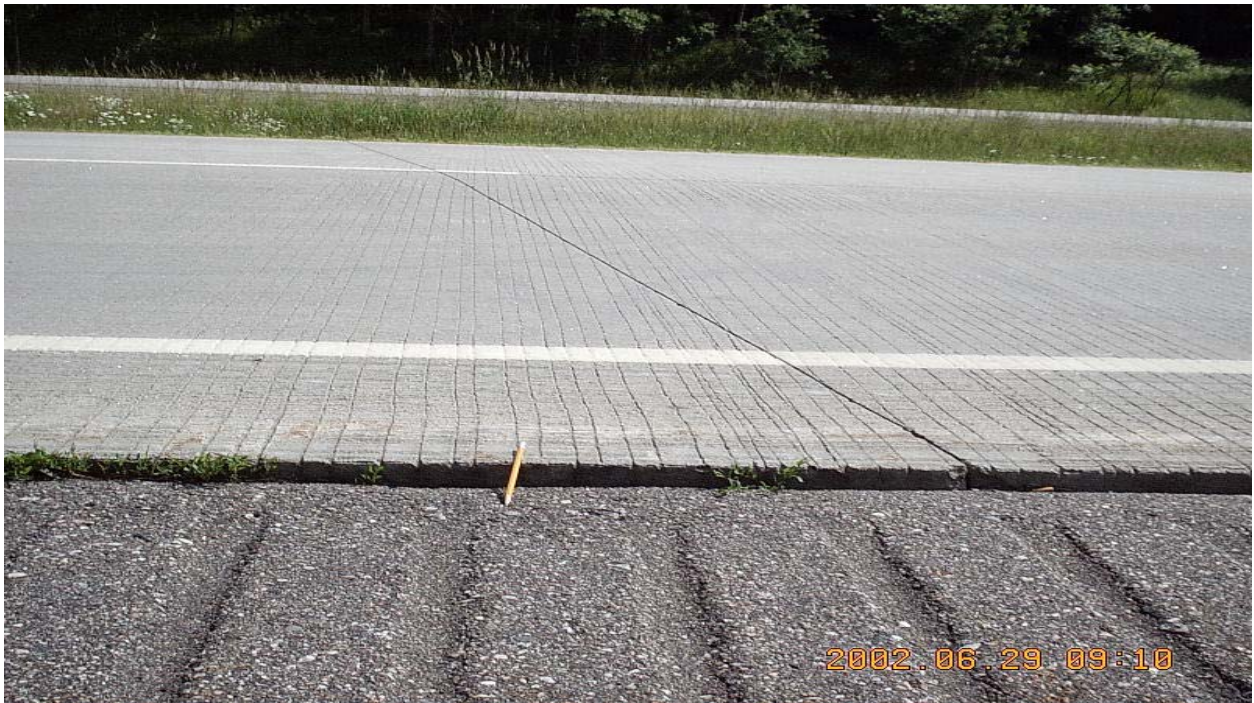
**Figure G-17 Shoulder Settlement Severity Level 3**

*[The AC shoulder component of this composite shoulder is at a lower elevation than the PCC slab. The measured average settlement was greater than 1-inch]*

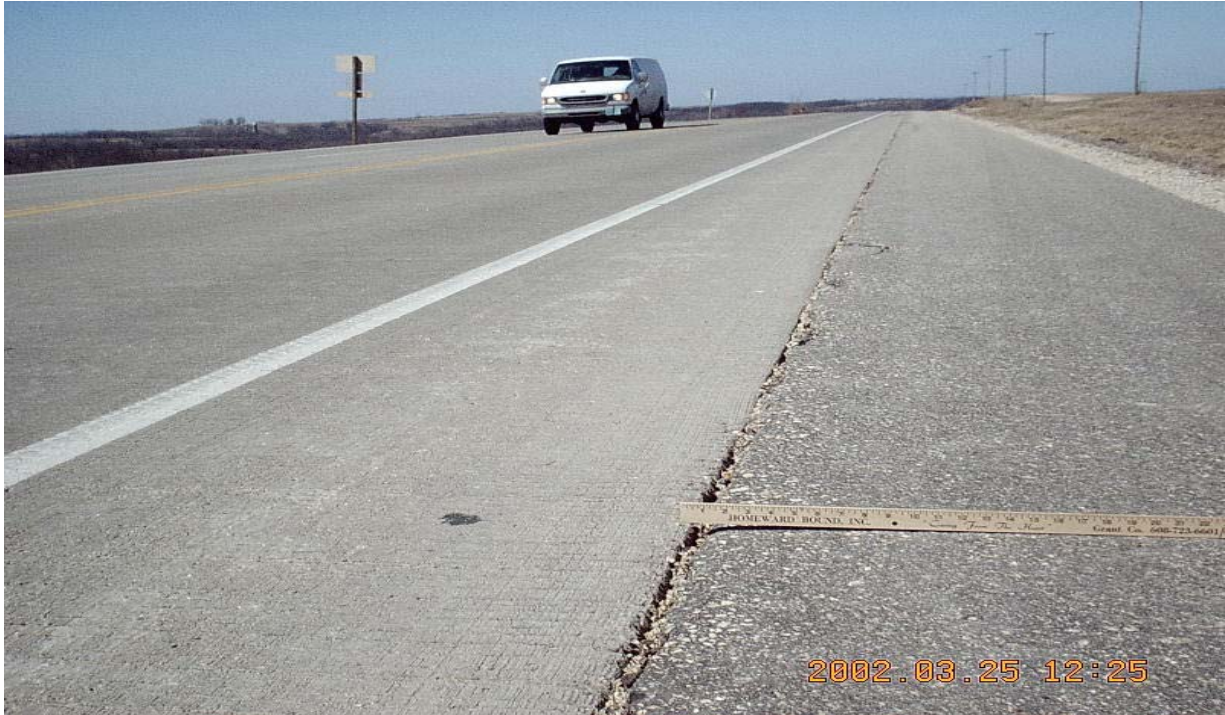
**Figure G-18 Shoulder Heave Severity Level 2**

*[The AC shoulder component of this composite shoulder is at a higher elevation than the PCC slab. The measured average heave was between ½ and 1-inch]*
